**2011 DRAGON 2 SYMPOSIUM**

# Water Resources and Environment Monitoring by Remote Sensing in Guanting Reservoir of China

Xin Jingfeng Li Jiren Li Xiaotao

Remote sensing center, IWHR, Ministry of Water Resources, China

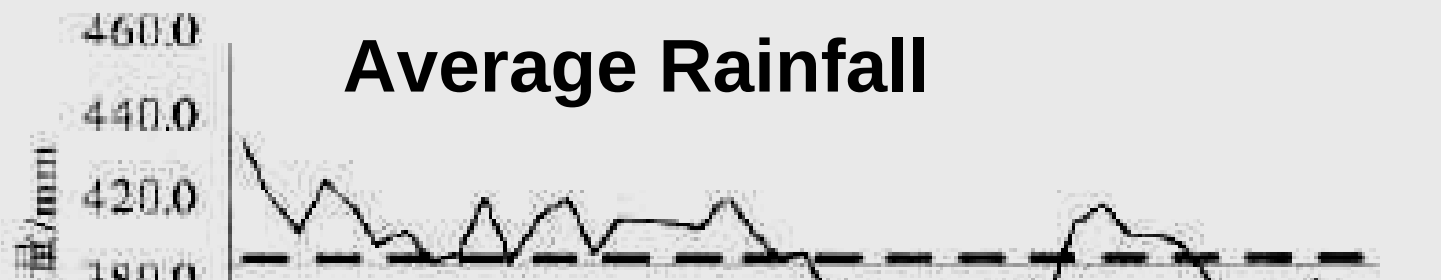
# Average Rainfall

官厅水库入库河流多年降雨量变化趋势
